HgCdTe Detector Reliability Study for the GOES Program

**David G. Seiler
George G. Harman
Jeremiah R. Lowney
Santos Mayo
Walter S. Liggett, Jr.**

**U.S. DEPARTMENT OF COMMERCE
National Institute of Standards
and Technology
Gaithersburg, MD 20899**

September 1991

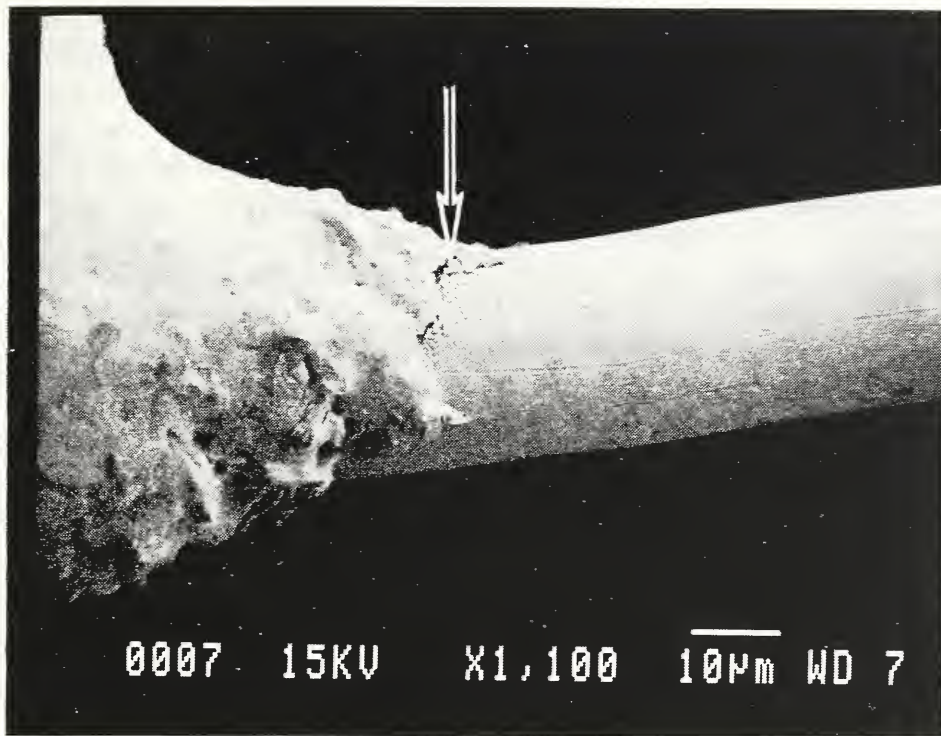
It would be speculation to say that this particular cracked wire would or would not fail in a given number of temperature cycles of a given temperature difference. If there is ductile gold below the crack, then it may take many cycles before failure, but if there is brittle intermetallic below,

Figure 6.10 An enlargement of the solder-gold wire interface revealing a crack is shown by the arrow.

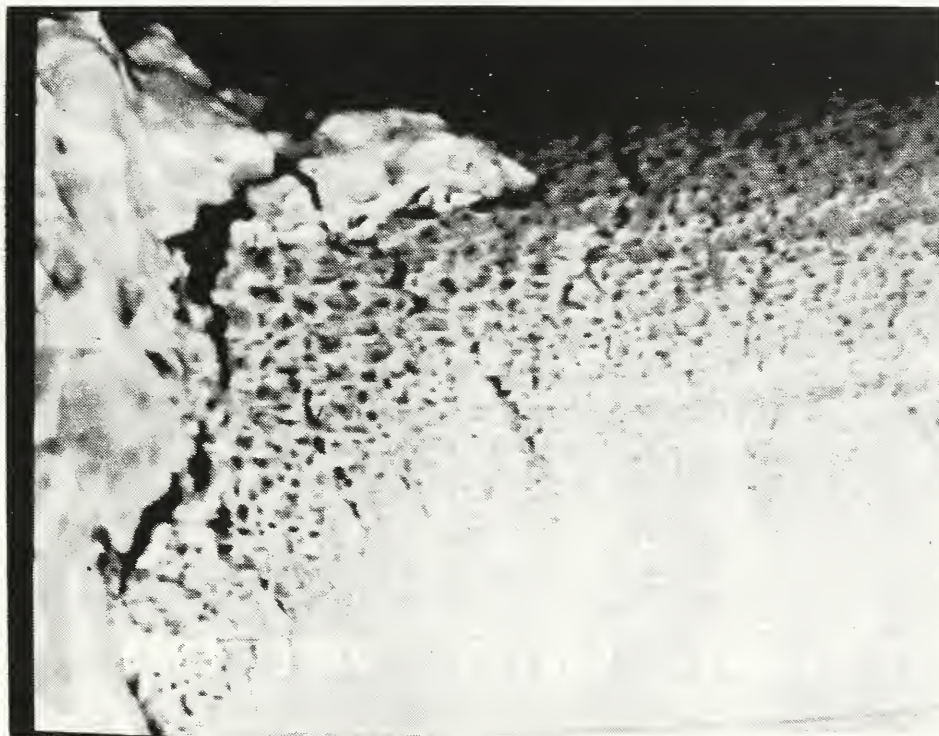
Figure 6.11 A further enlargement of the solder gold wire intersection. A large crack is evident as well as several smaller cracks. The dimpled surface is the result of tin diffusing out along the gold wire and forming gold-tin intermetallics.

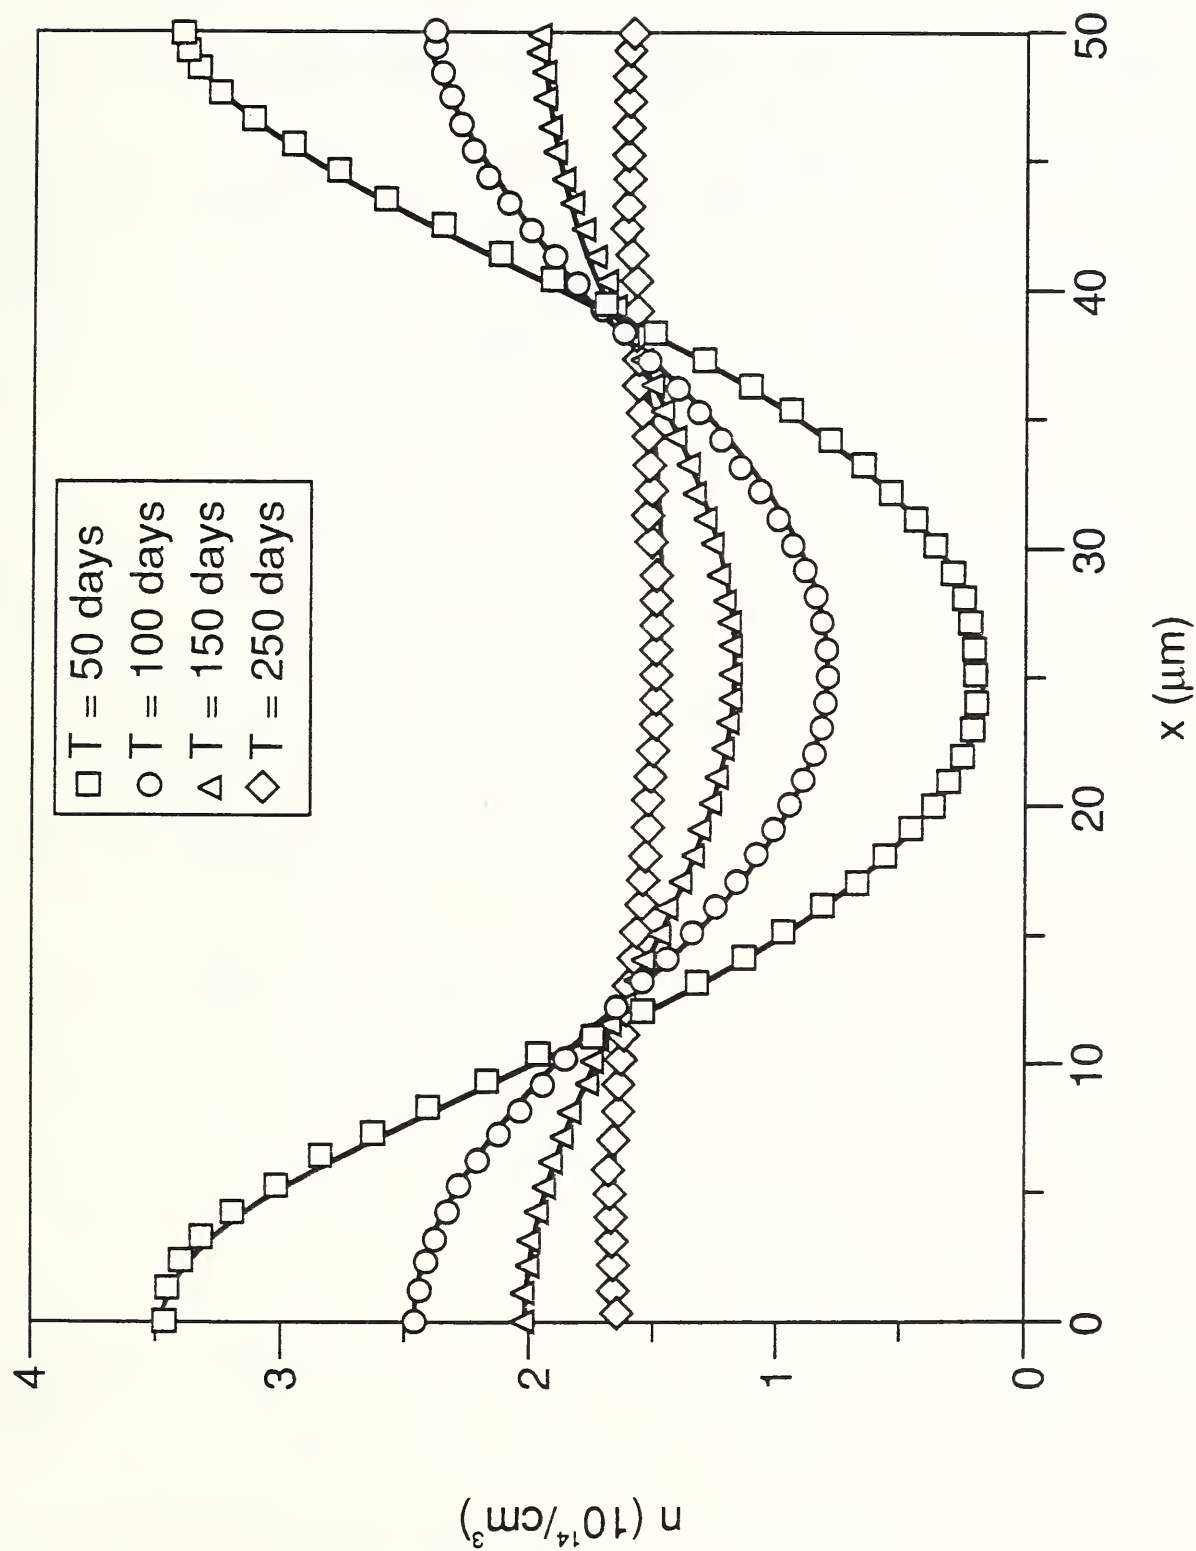
MERCURY DIFFUSION IN MCT

- **Excess mercury diffusion resulting from the ion-beam milling fabrication step.** The ion-milling introduces a thin layer of excess mercury, which could diffuse into the bulk in about a year. The resulting increase in electron density could cause the signal to decrease primarily because of the sweepout effect.
- **Delamination of the ZnS anti-reflection optical coating.** Organics and other residual products could be trapped under the ZnS optical coating and prevent its molecular bonding to the HgCdTe or passivation layer.

Figure 6.12 Mercury profile in HgCdTe at 300 K as a function of position for times of 50, 100, 150, and 250 days. The electron density is assumed to be equal to that of the mercury, and the background carriers density has been ignored. Initially, the mercury was assumed to be concentrated at the two edges. The width of the sample is 50 μm .

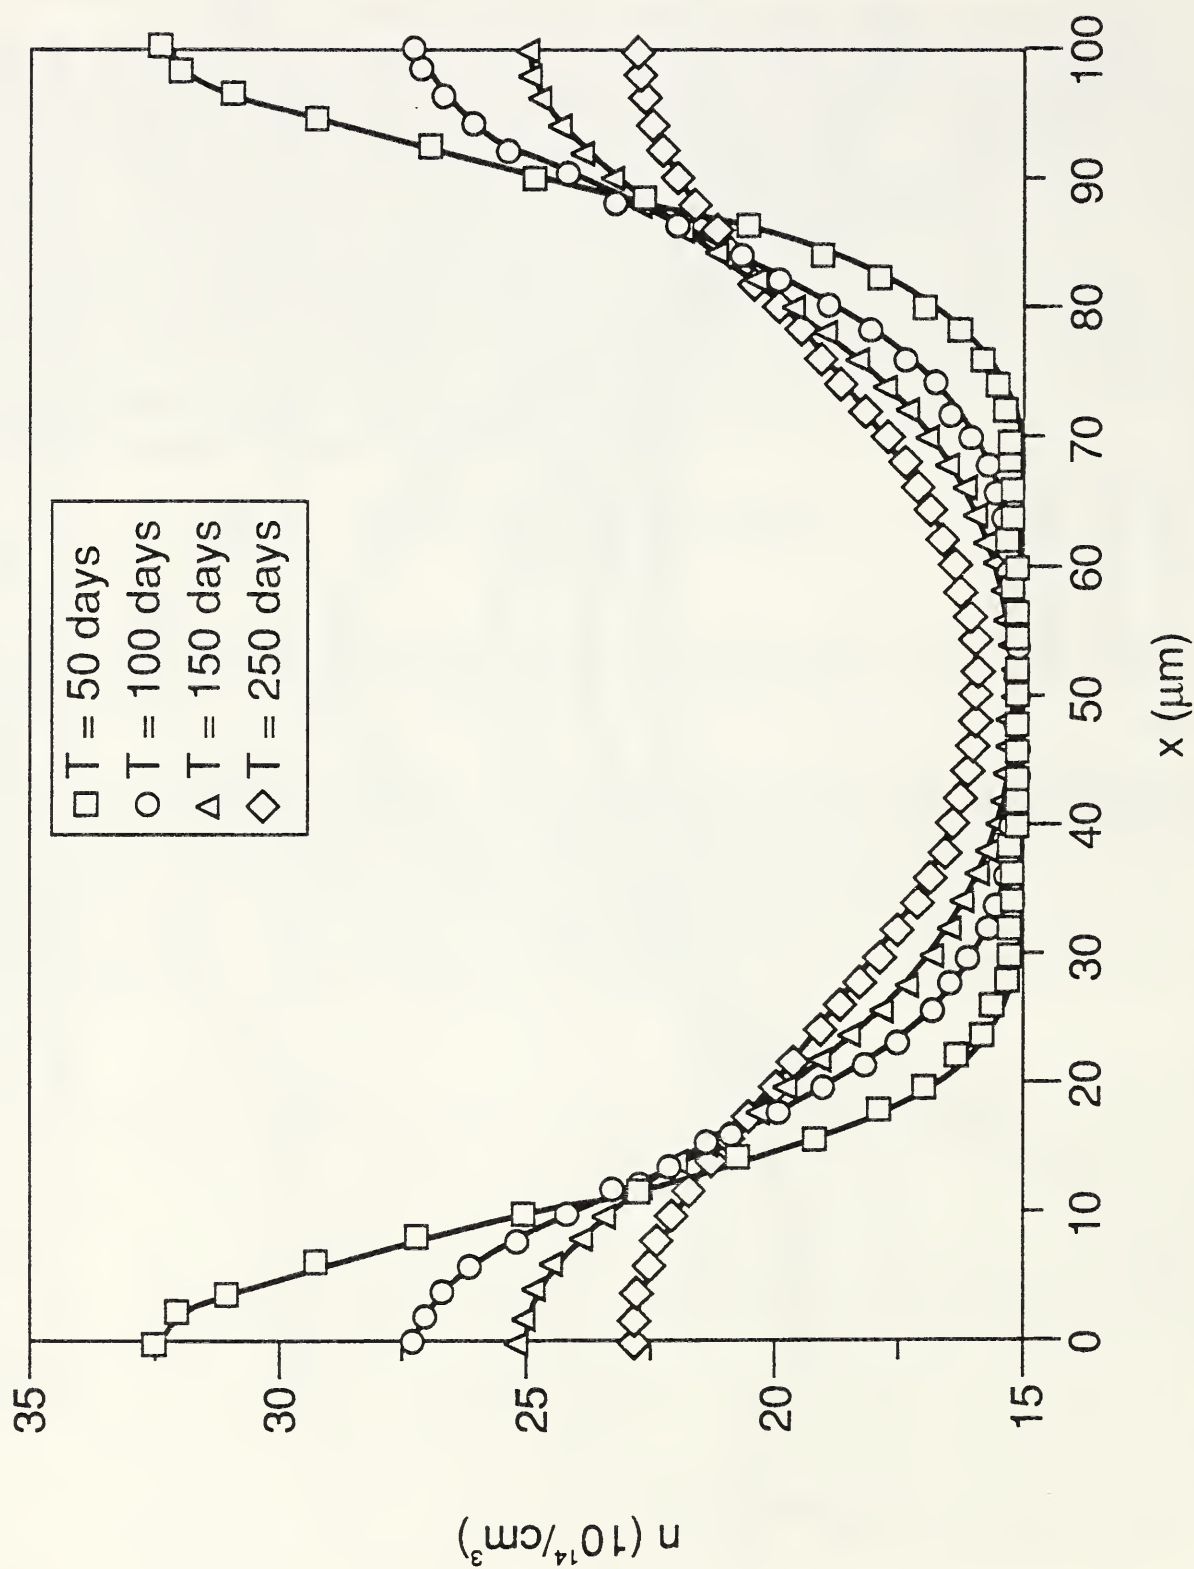
MERCURY DIFFUSION IN MCT

Figure 6.13 Mercury profile in HgCdTe at 300 K as a function of position for times of 50, 100, 150, and 250 days. The electron density is assumed to be equal to that of the mercury, and the background carrier density has been ignored. Initially, the mercury was assumed to be concentrated at the two edges. The width of the sample is 100 μm .

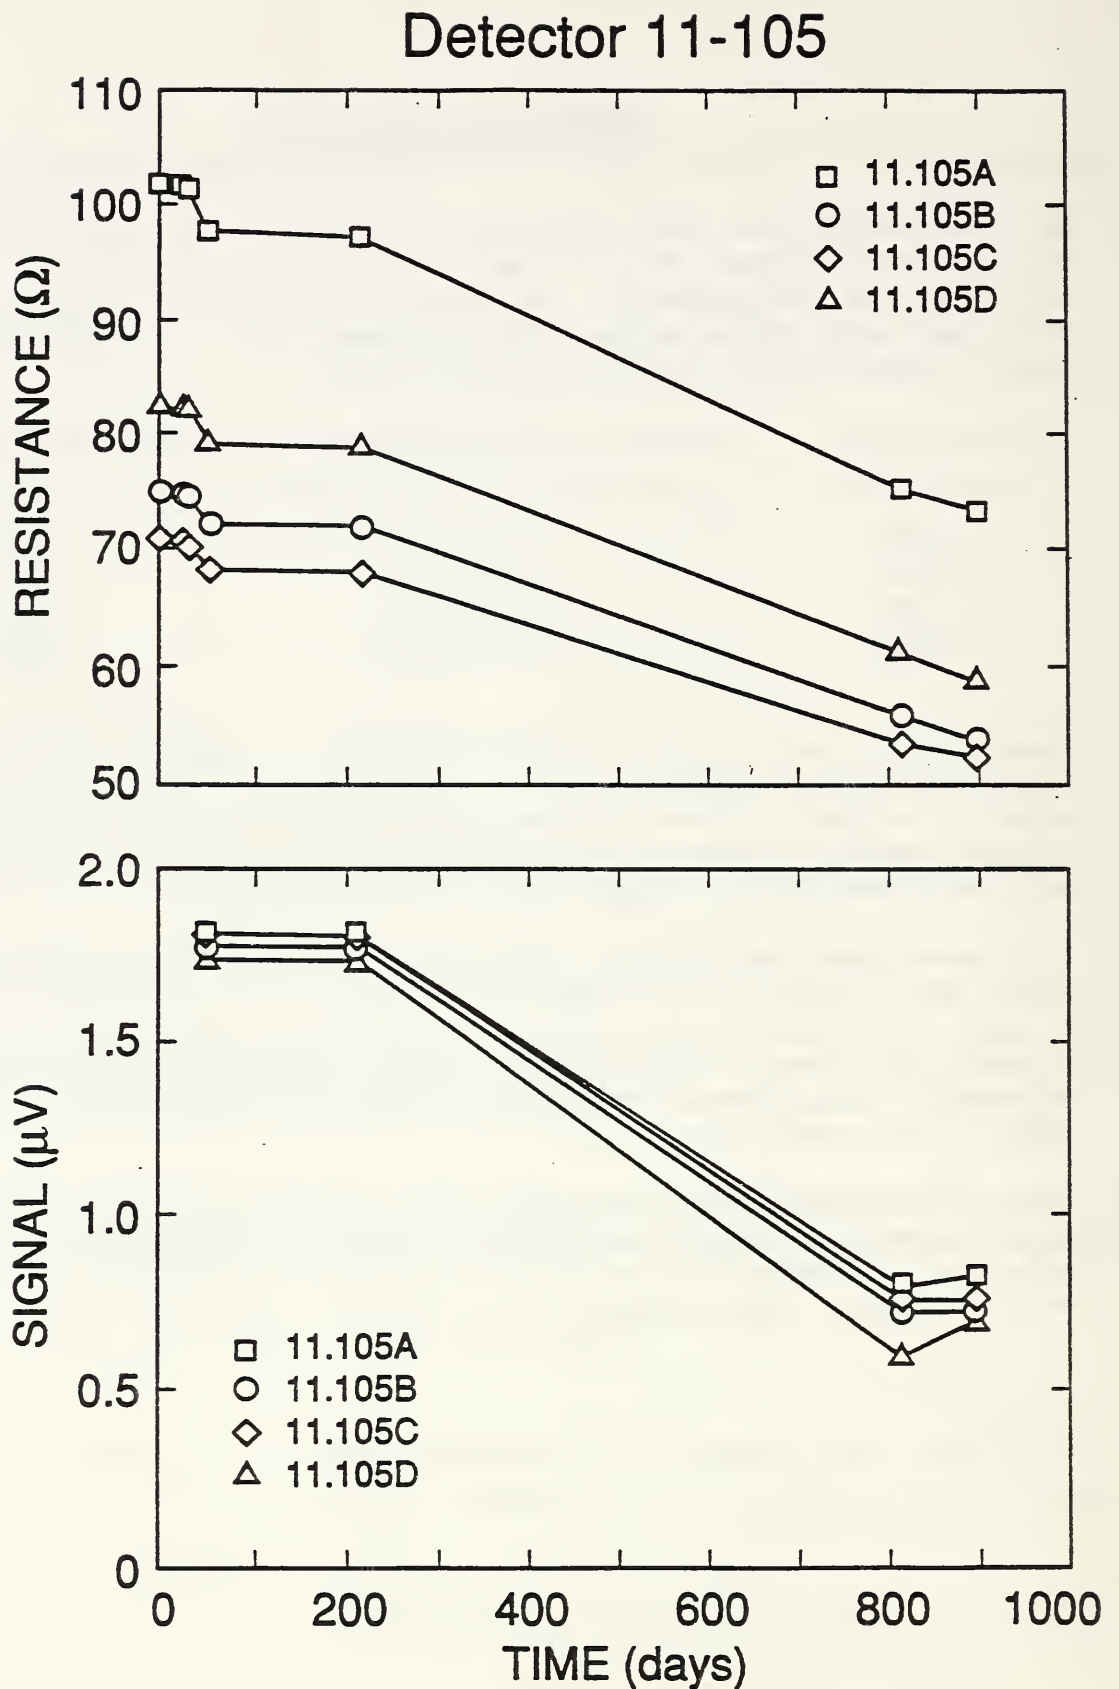
Figure 1. Variation of the resistance and signal of each element with time for detector 11-105 (a four element array) at a temperature of 105 K. All data were obtained from records supplied by ITT. As noted in the Table for 11-105, all data were taken by the supplier, except for the measurements on 3/20/91 (818 days) which were taken by ITT staff. Only the post-aplanat signal data are plotted.

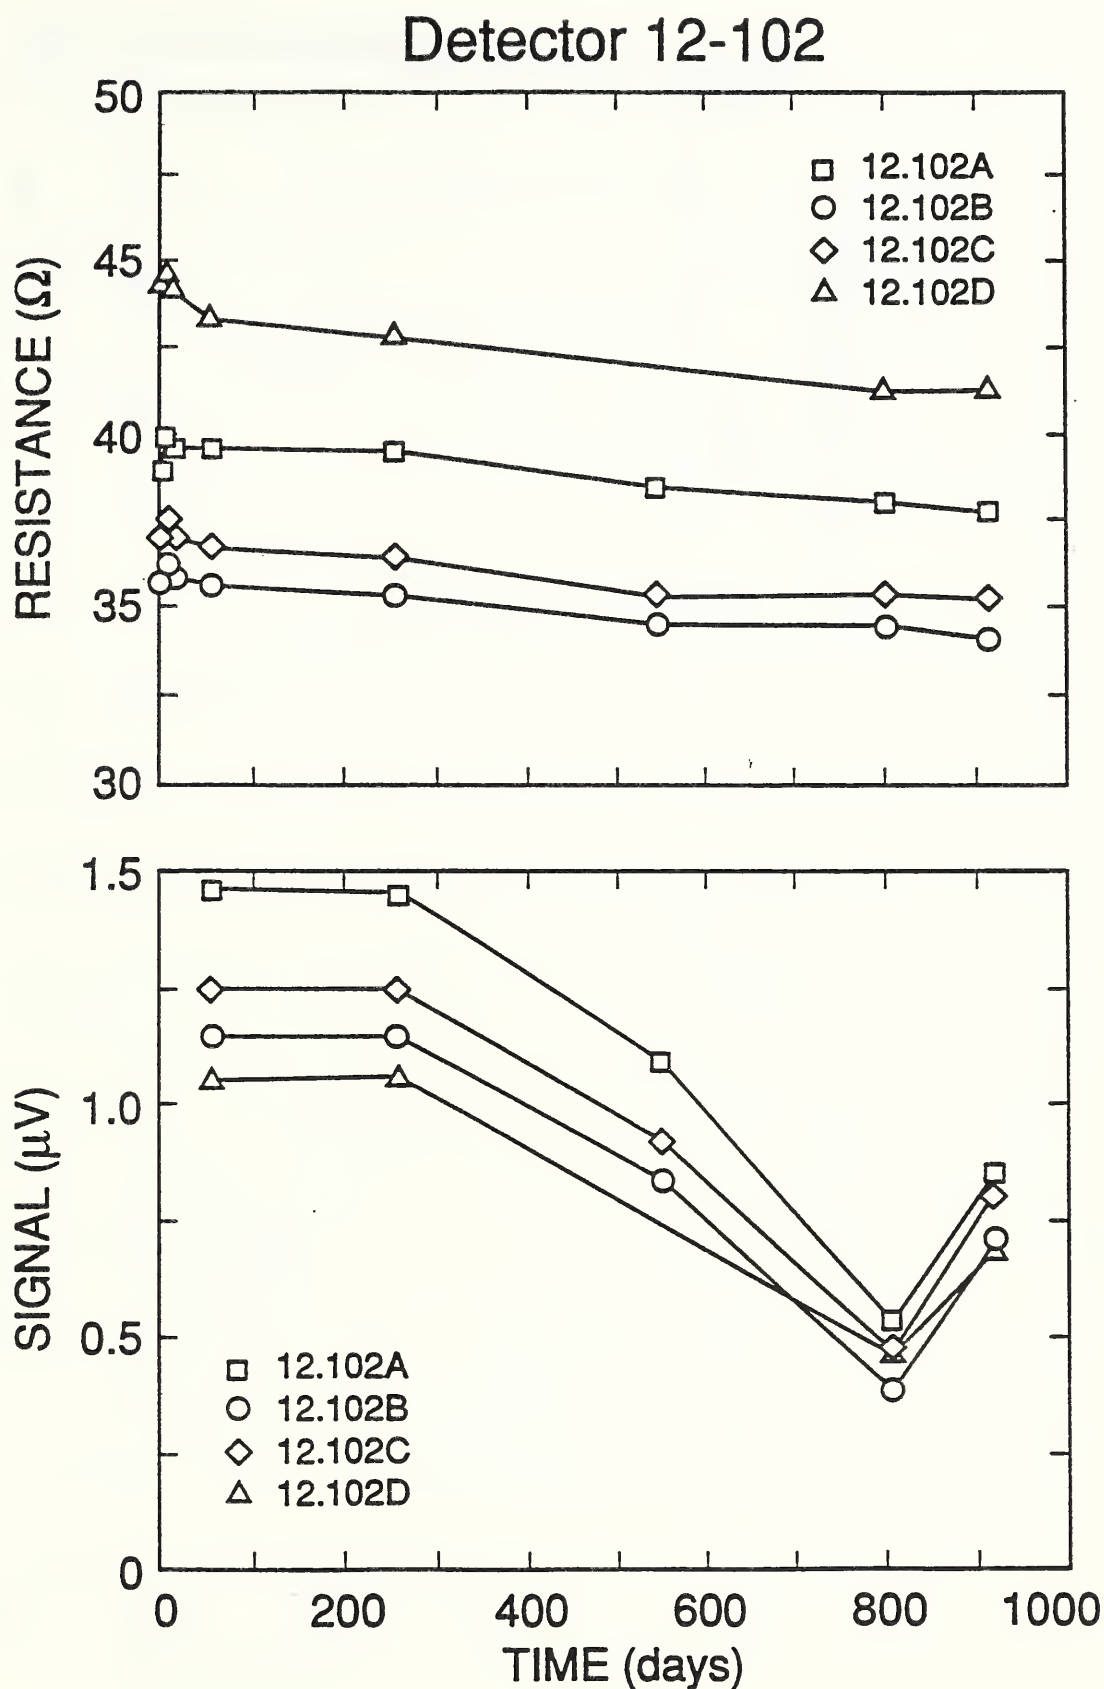
Figure 2. Variation of the resistance and signal of each element with time for detector 12-102 (a four element array) at a temperature of 105 K. All data were obtained from records supplied by ITT. As noted in the Table for 12-102, all data were taken by the supplier, except for the measurements on 2/19/91 (805 days) which were taken by ITT staff. Only the post-aplanat signal data are plotted.

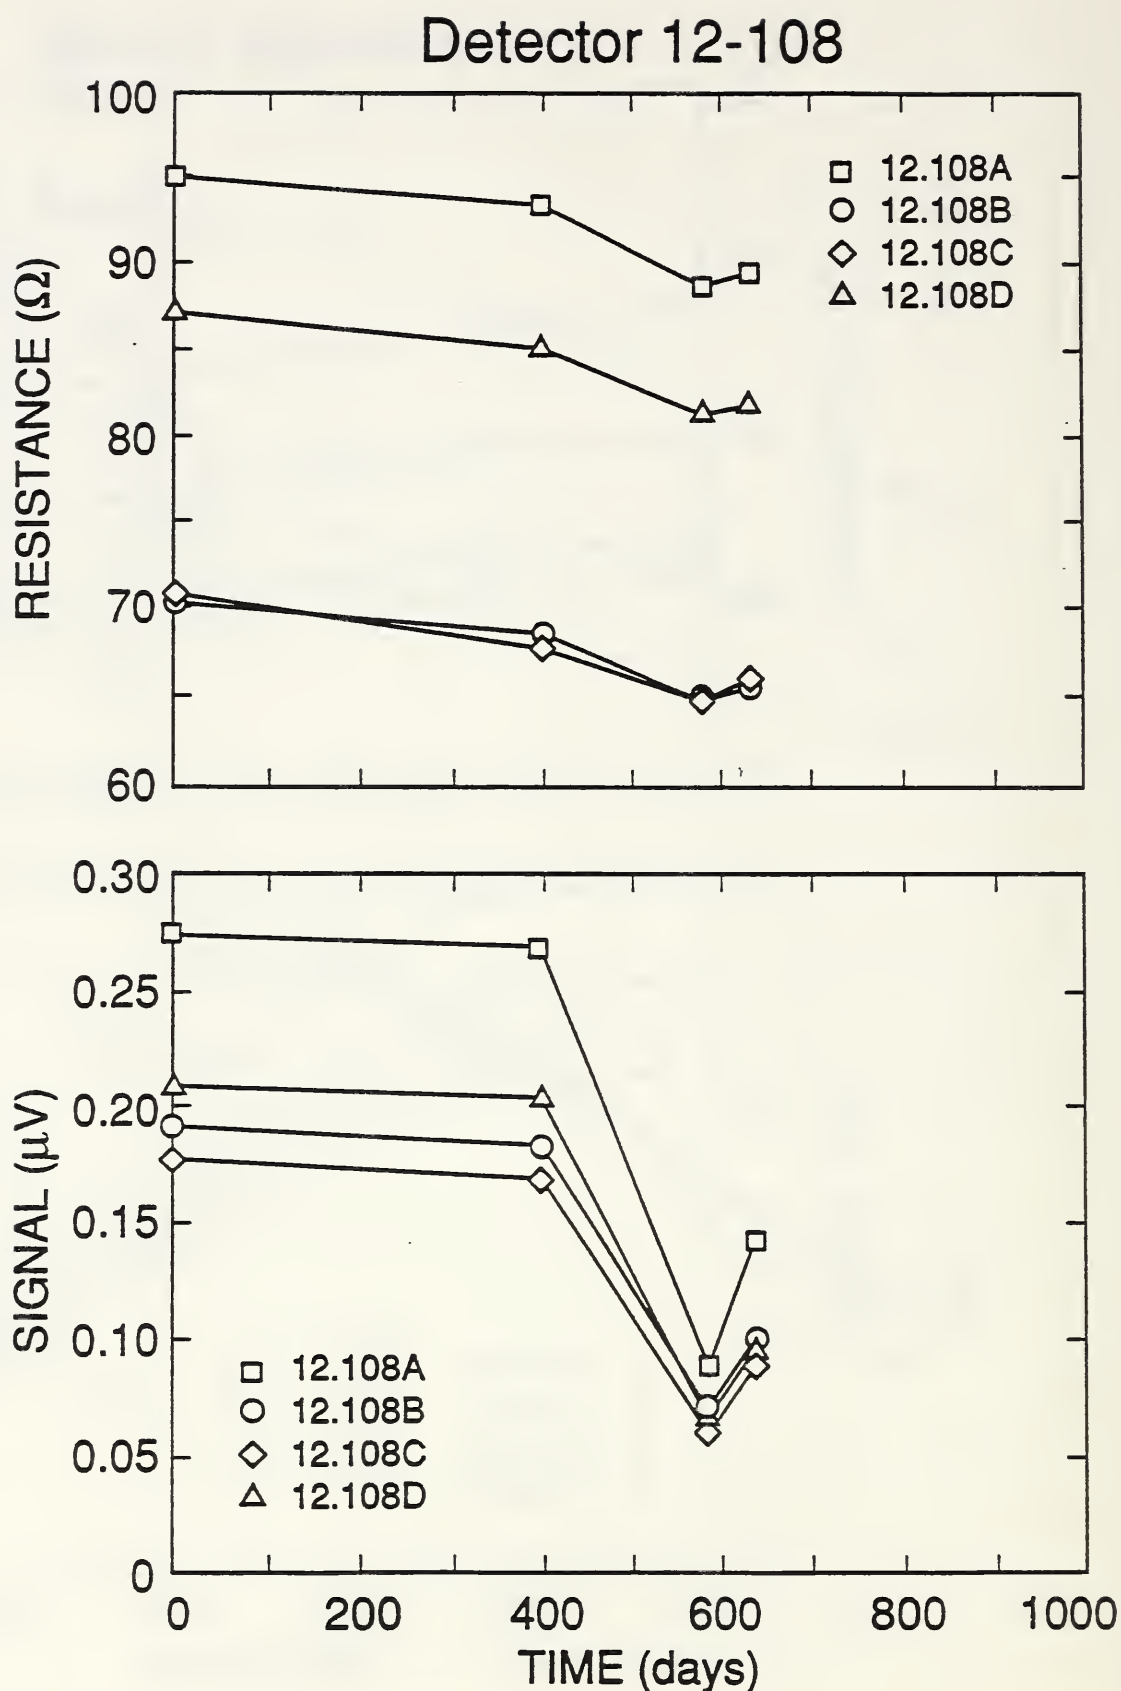
Figure 3. Variation of the resistance and signal of each element with time for detector 12-108 (a four element array) at a temperature of 105 K. All data were obtained from records supplied by ITT. As noted in the Table for 12-108, all data were taken by the supplier, except for measurements on 12/12/90 (581 days), which were taken by CE staff. This is a bare detector; no aplanat was ever installed.

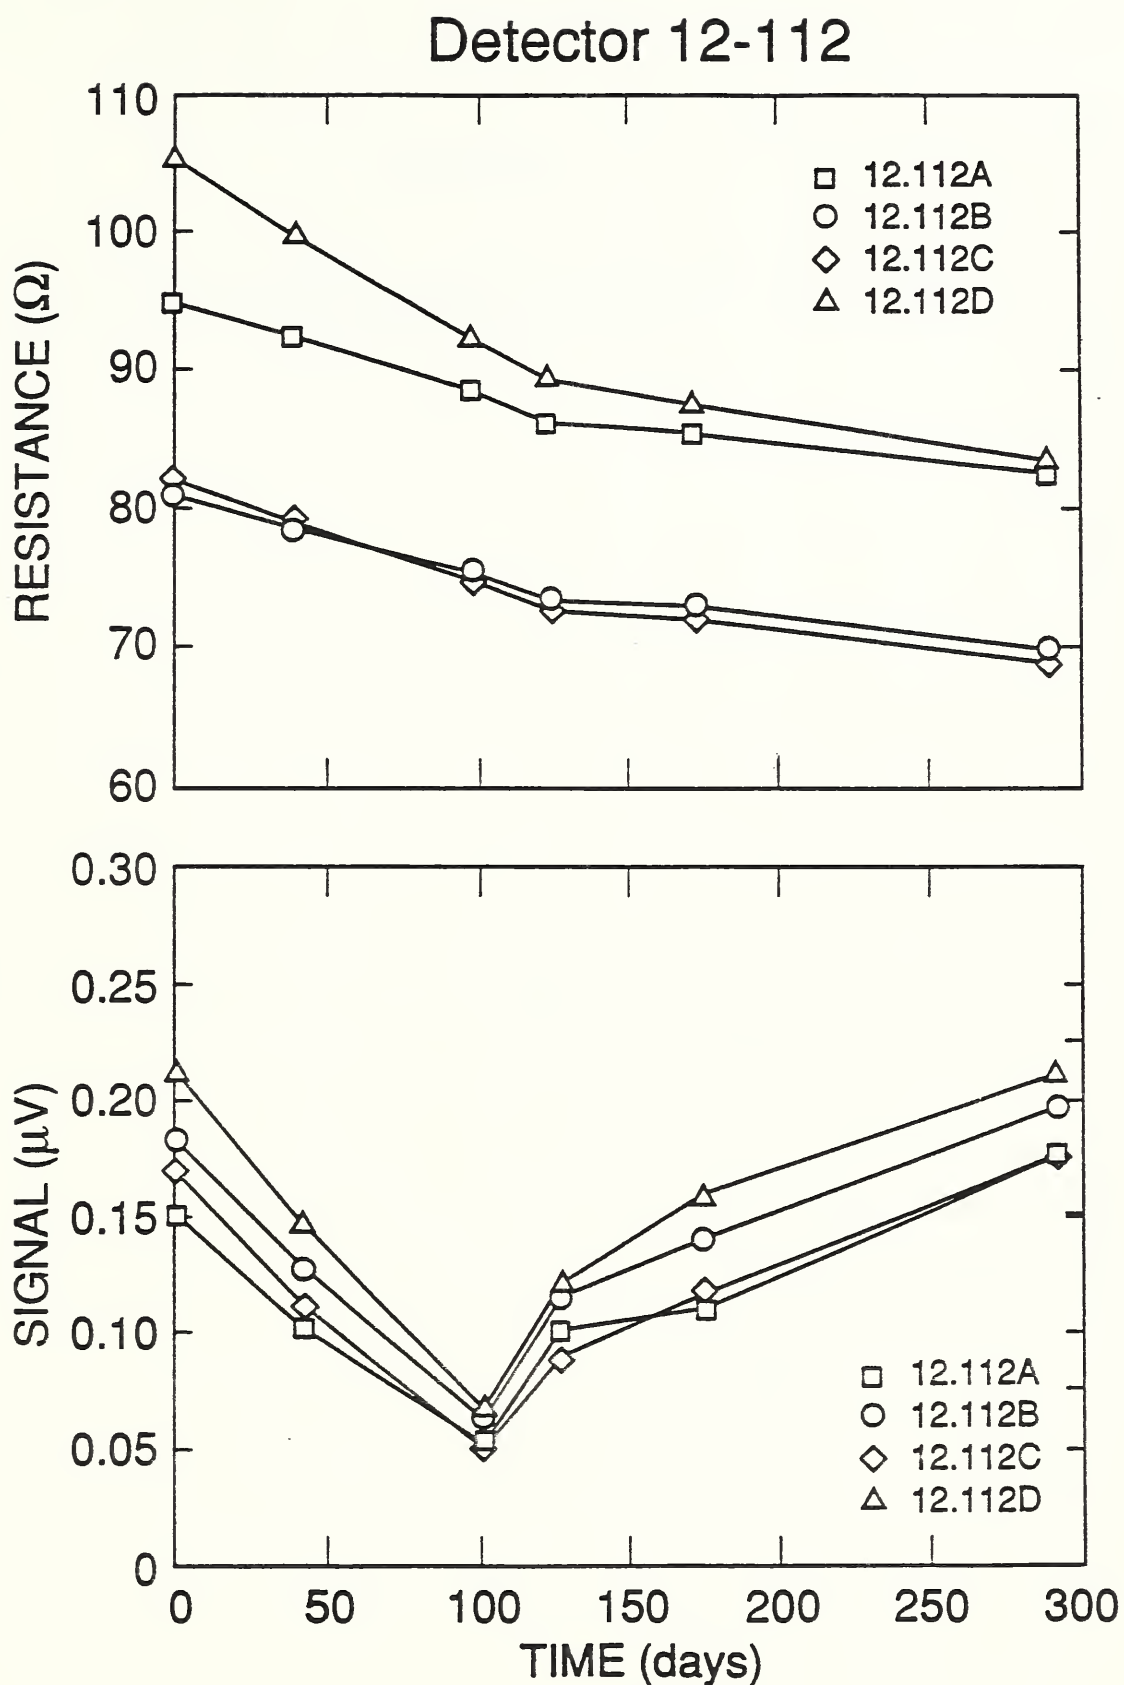
Figure 4. Variation of the resistance and signal of each element with time for detector 12-112 (four element array) at a temperature of 105 K. All data were obtained from records supplied by ITT. As noted in the Table for 12-108, all data were taken by the supplier. This is a bare detector; no aplanat was ever installed.

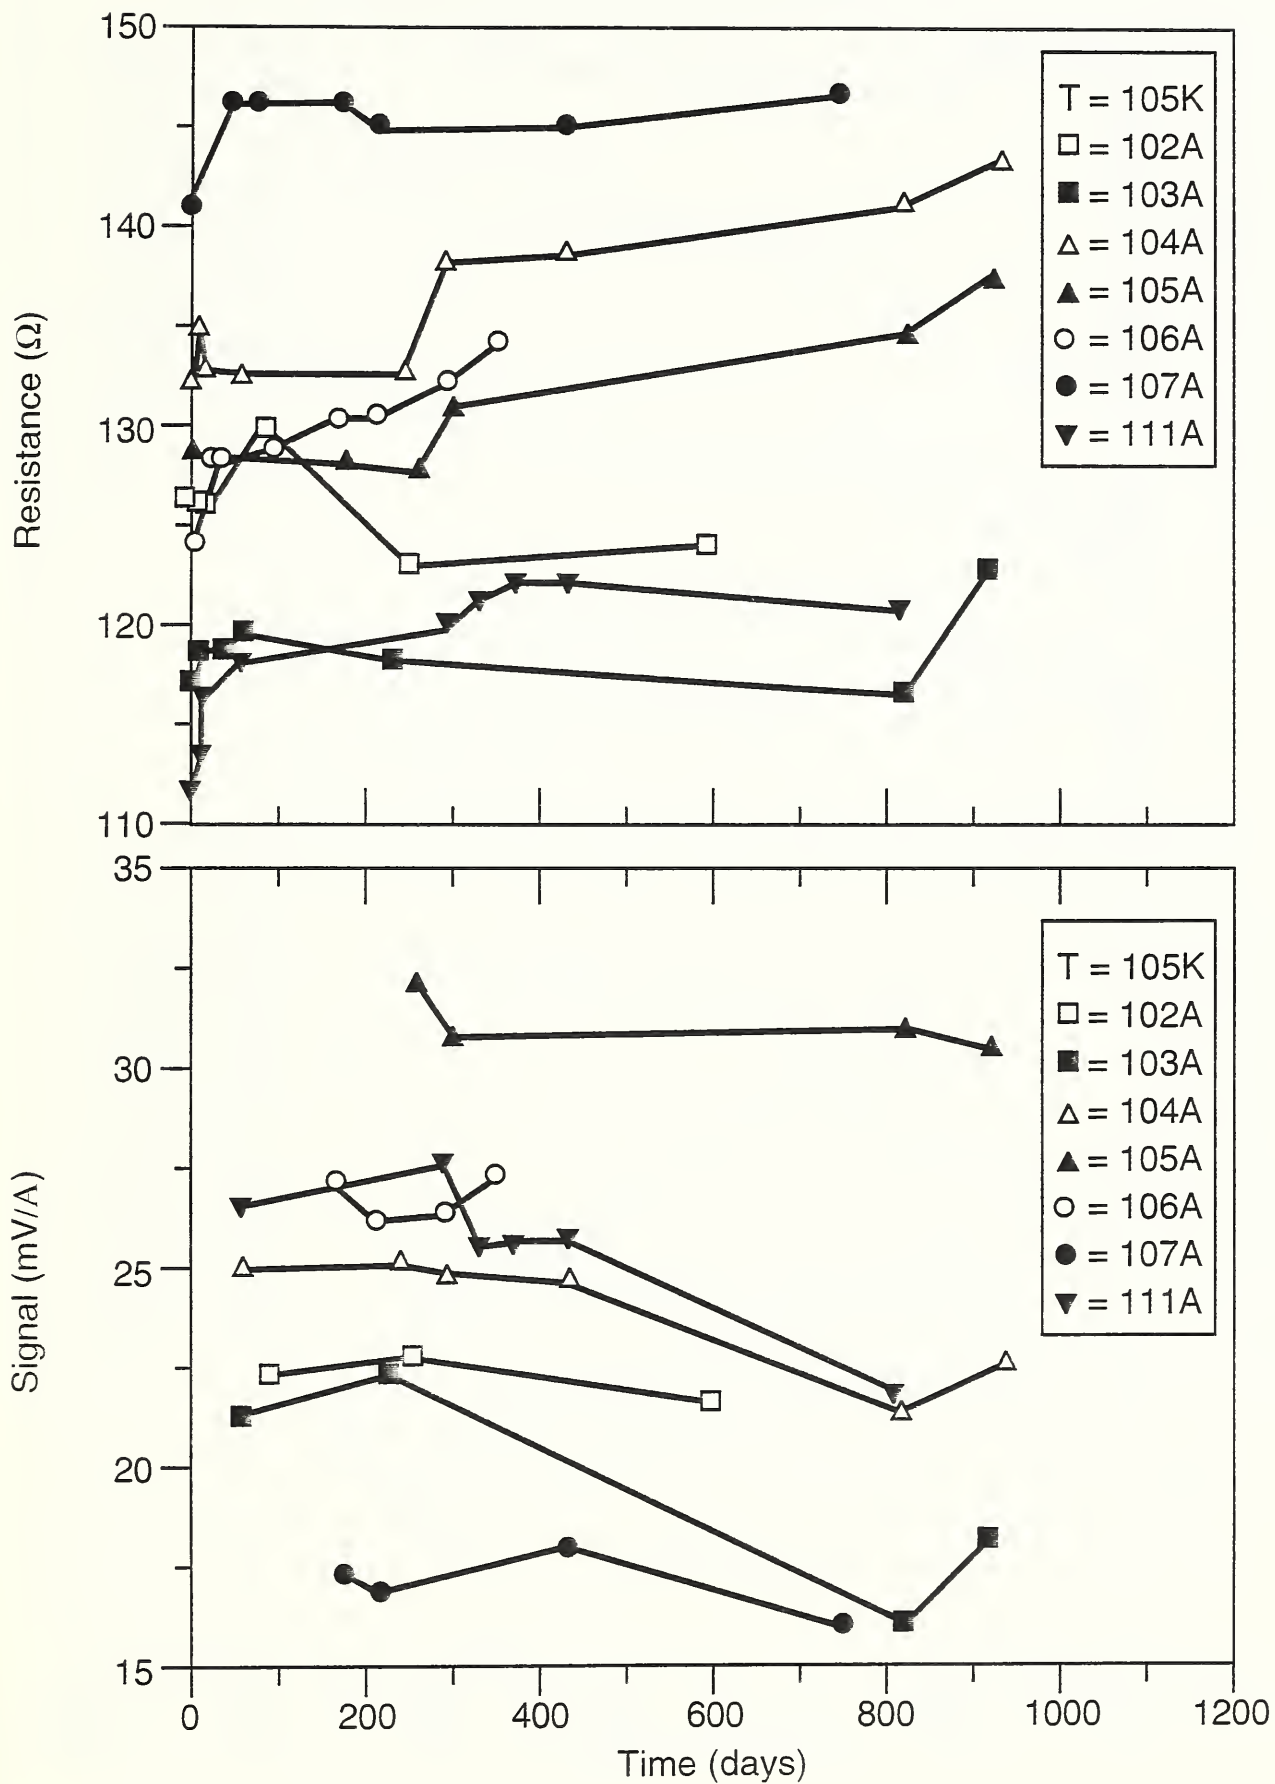
Figure D.1 Resistance (top) and signal (bottom) of element A of the 7- μ m detectors with aplanat lens as a function of time.

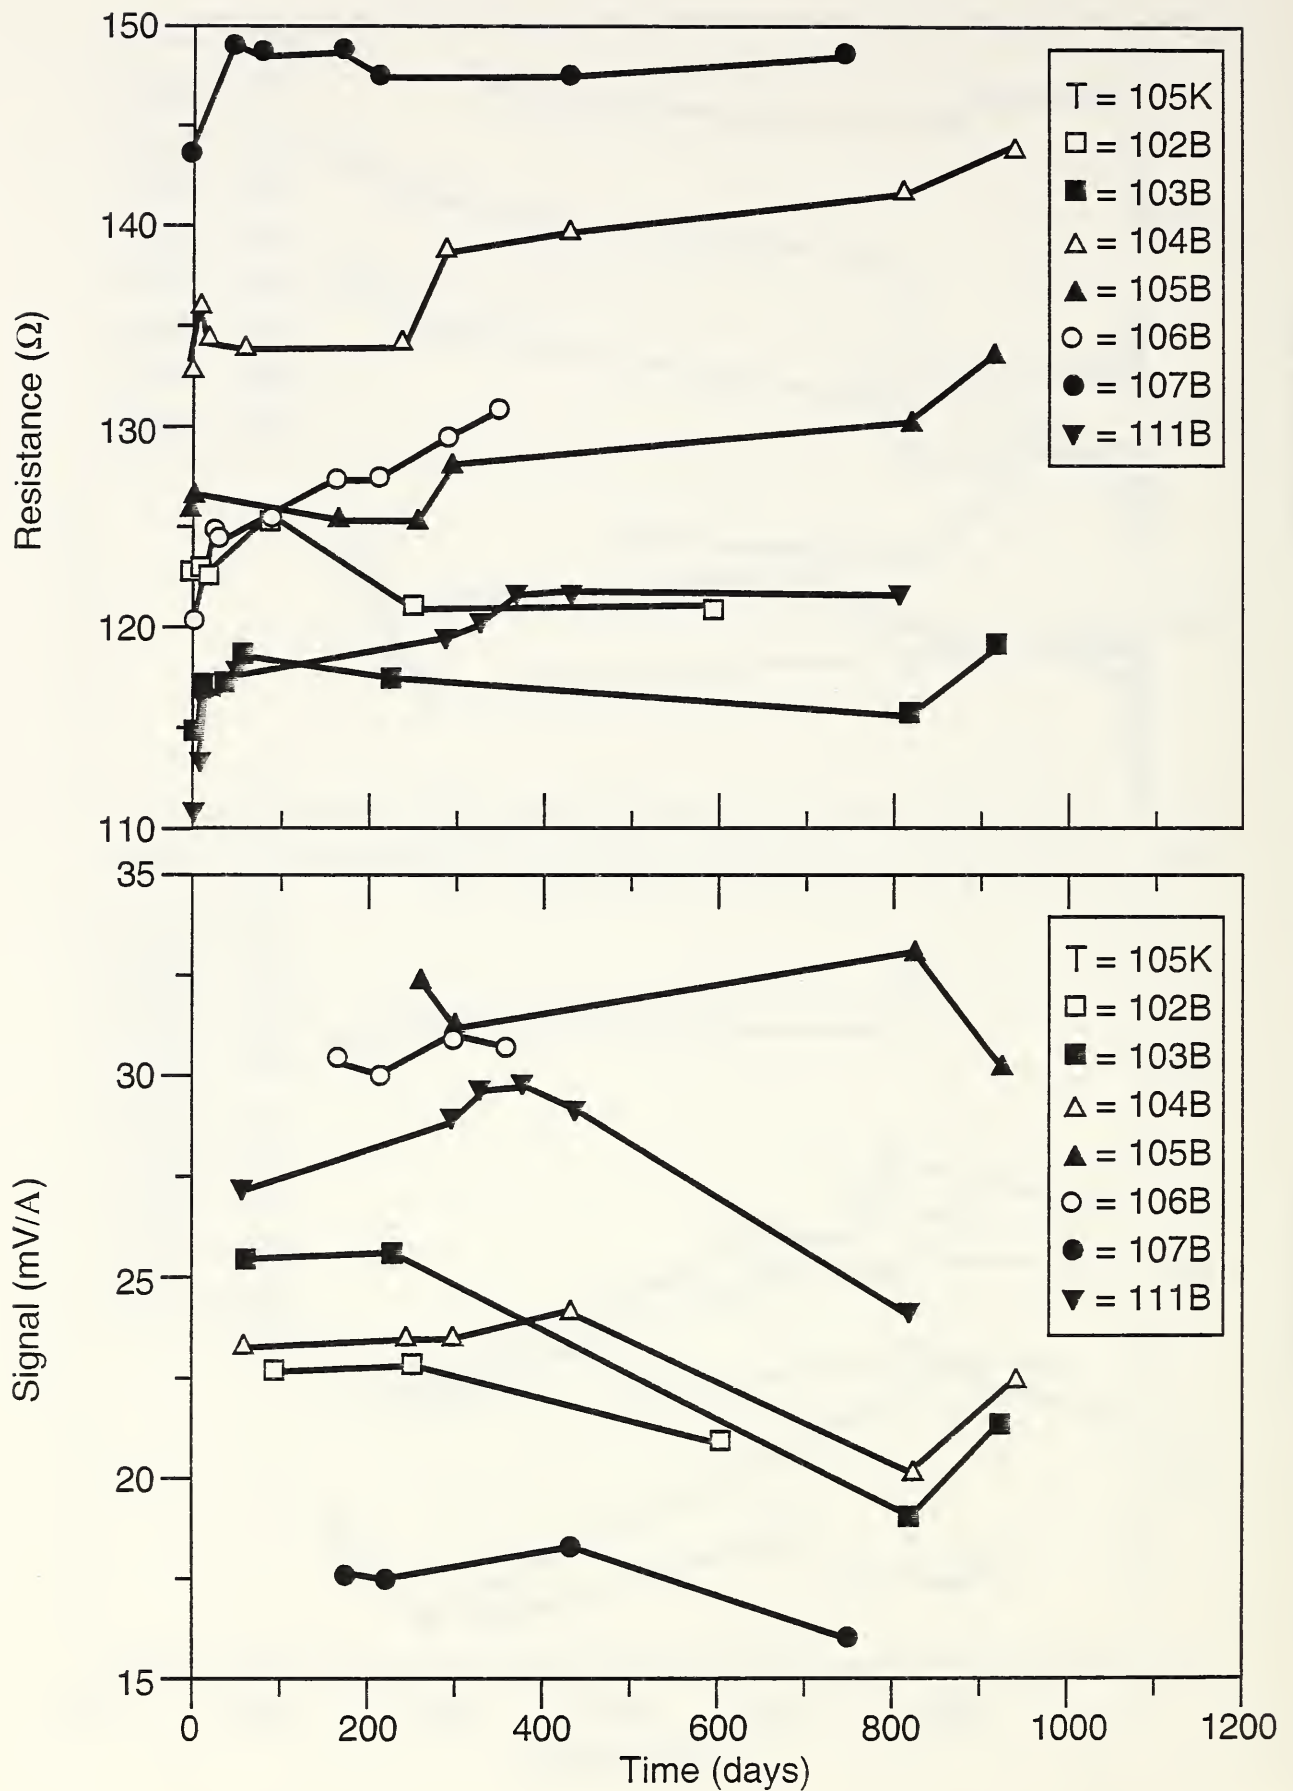
Figure D.2 Resistance (top) and signal (bottom) of element B of the 7- μ m detectors with aplanat lens as a function of time.

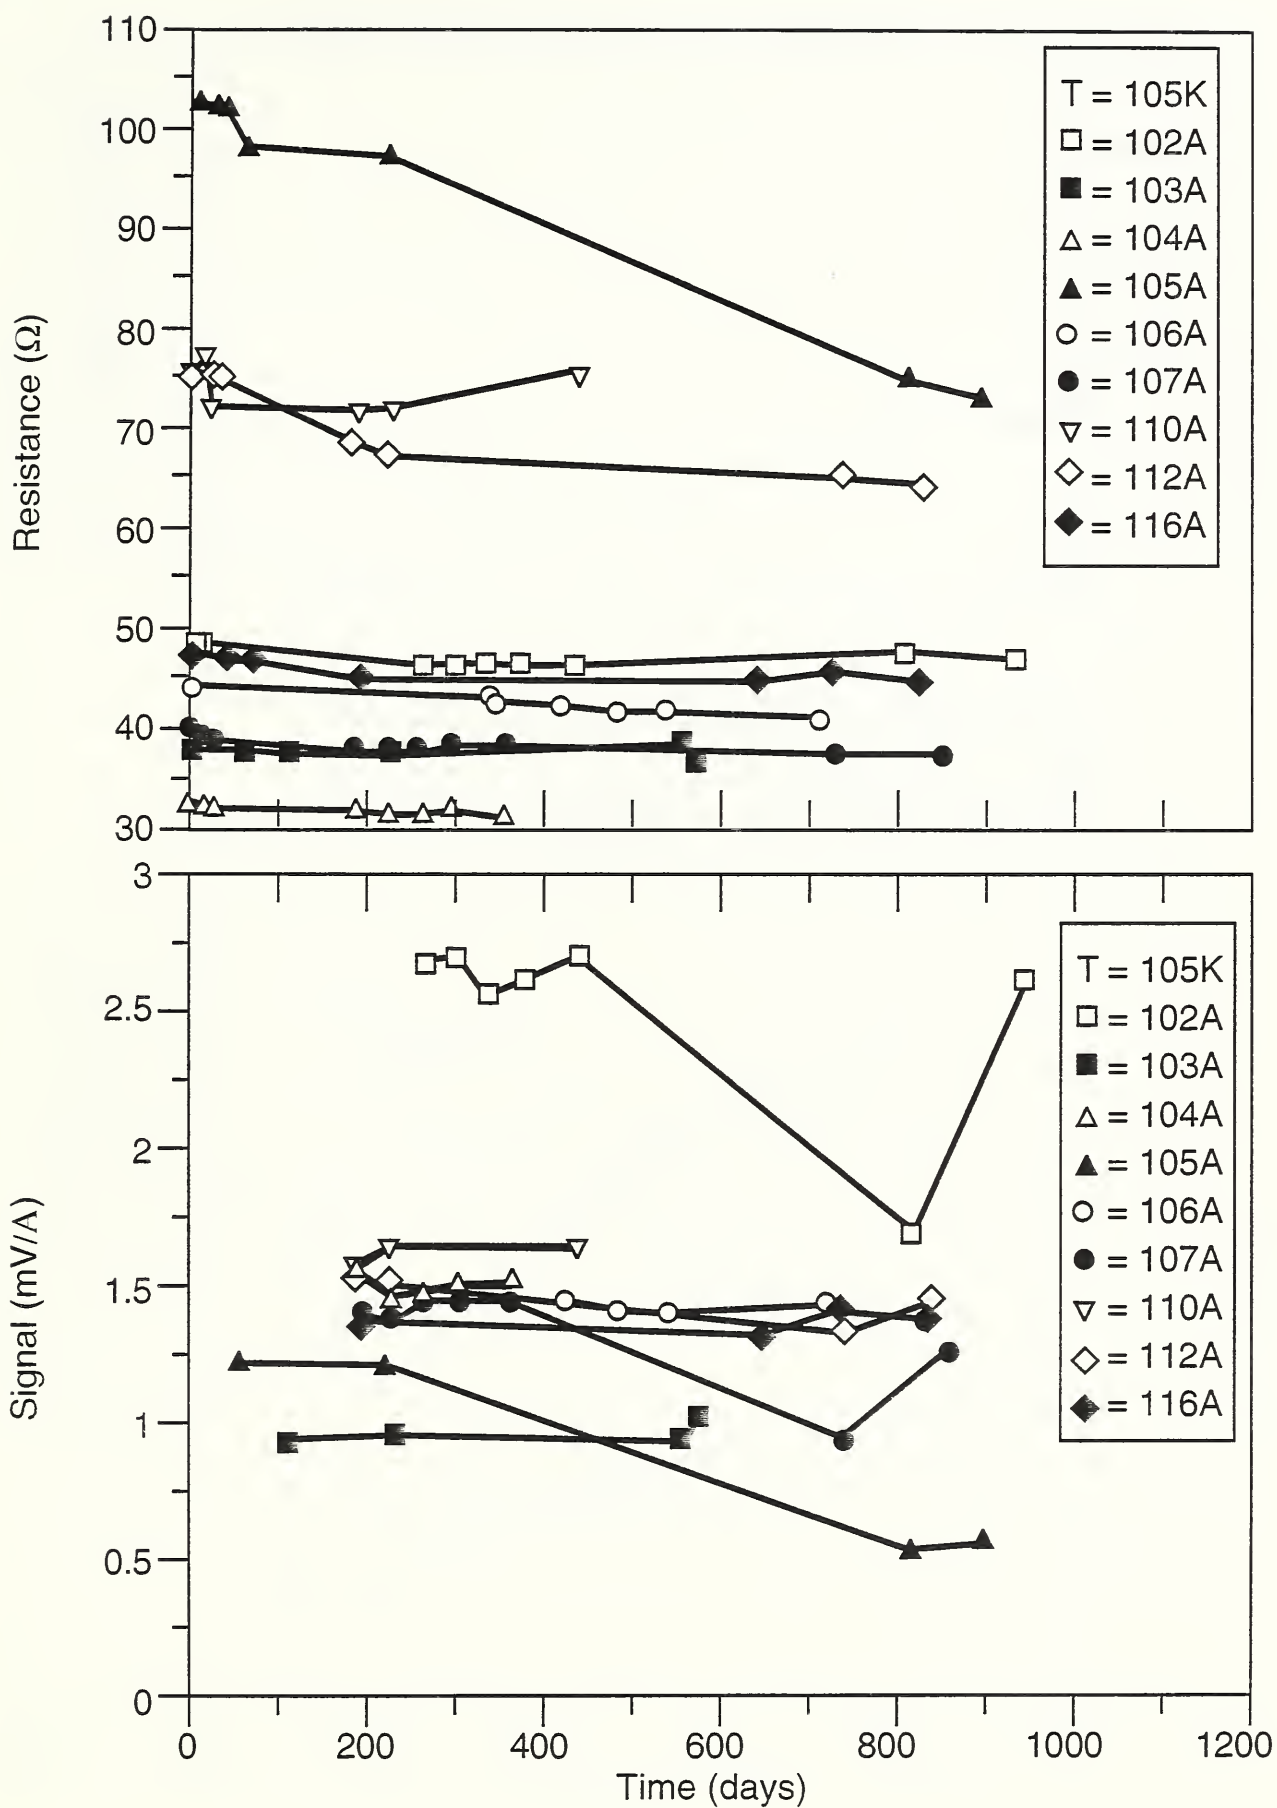
Figure D.3 Resistance (top) and signal (bottom) of element A of the 11-μm detectors with aplanat lens as a function of time.

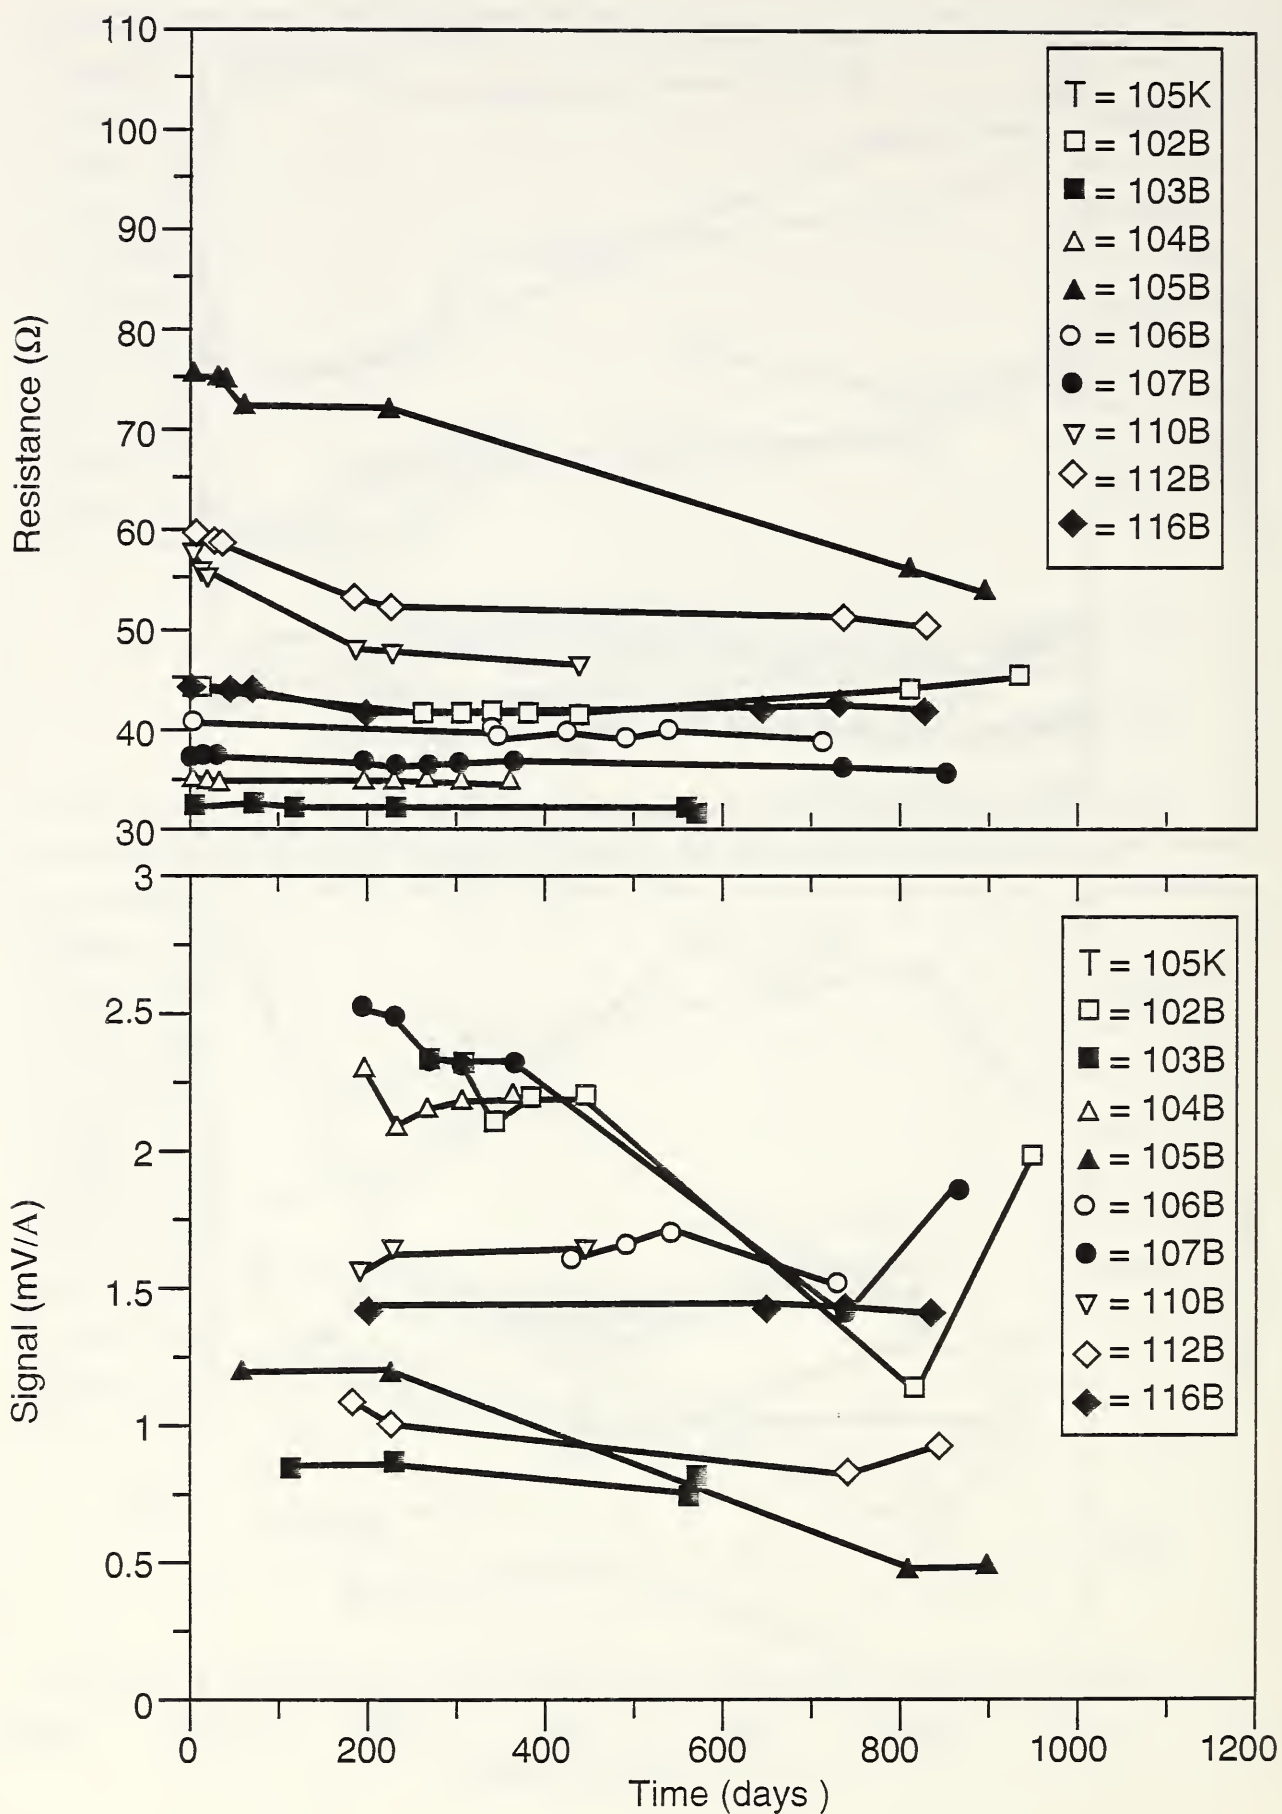
Figure D.4 Resistance (top) and signal (bottom) of element B of the 11- μ m detectors with aplanat lens as a function of time.
